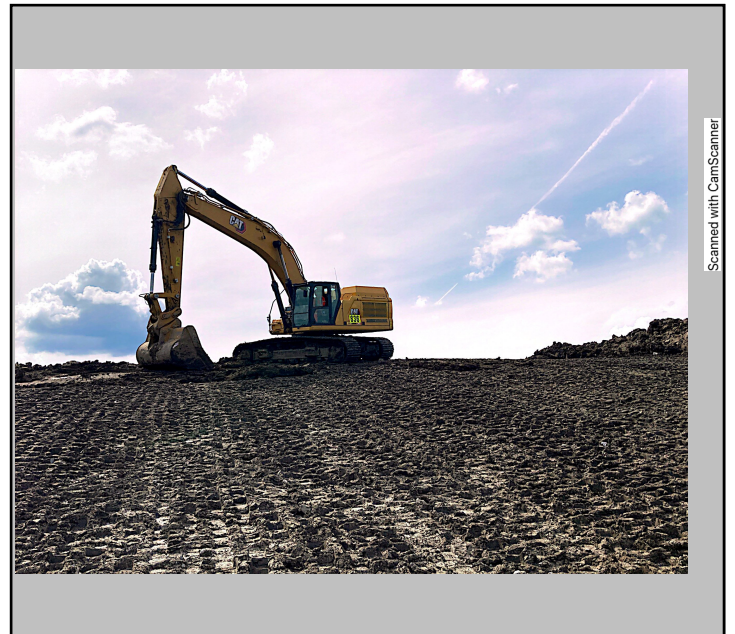
Photo #: 4

Excavator 836 replacing dry CCL material on P31.

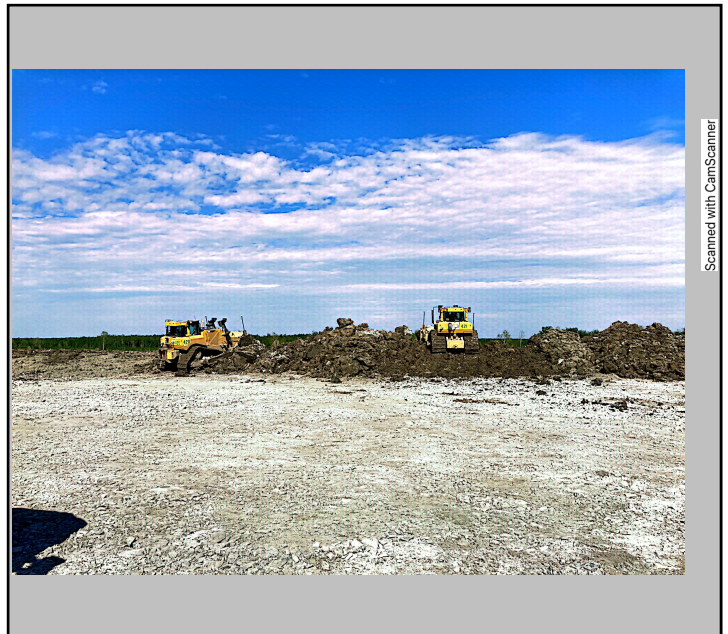
Photo #: 4

Dozer 420 and 421 Removing over built from P30 and starting to place NCL L4 P31.

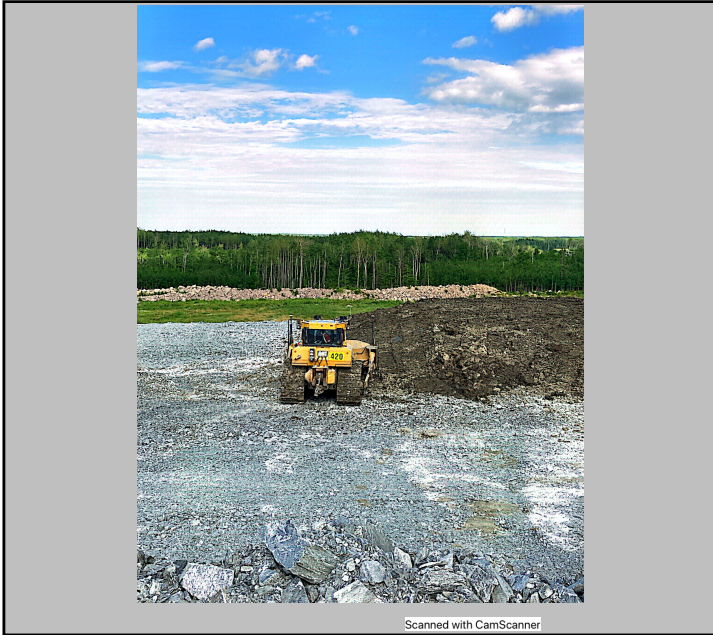
Photo #: 5

Dozer 420 sloping north edge of P30.

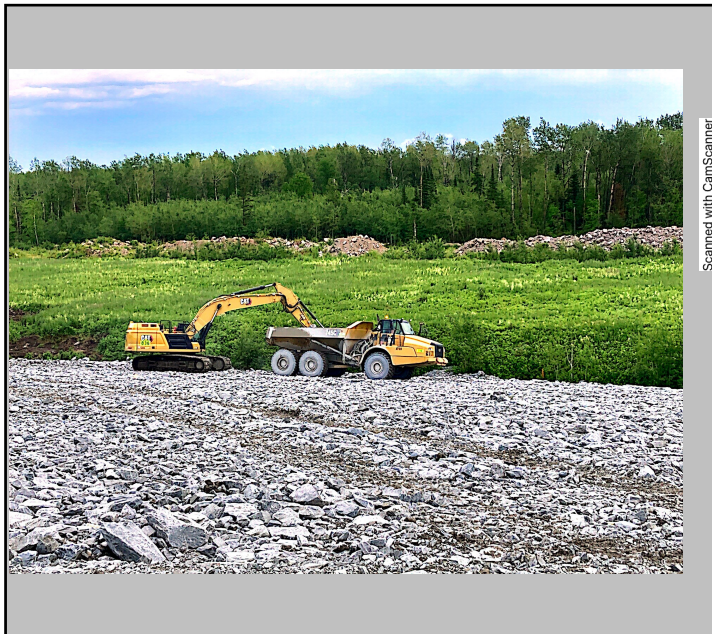
Photo #: 3

Excavator 836 removing oversize rock from toe of rock slope south of STA 0+661.

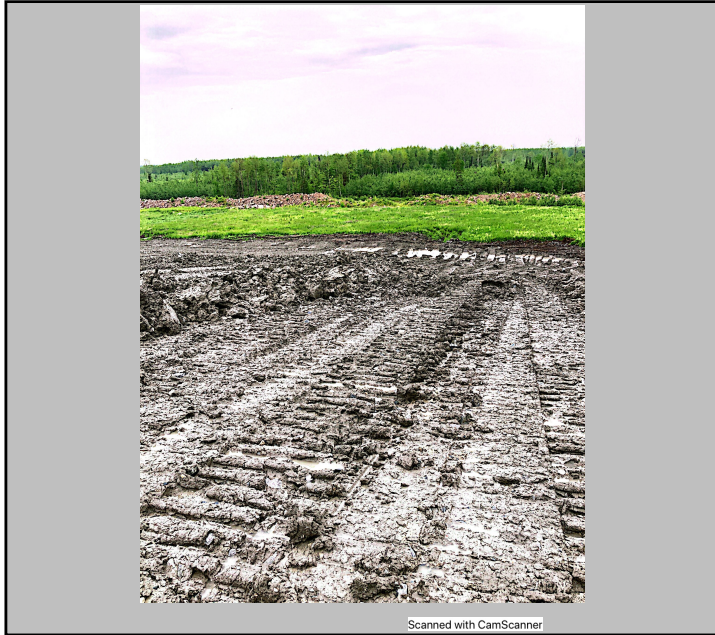
Photo #: 1

P31 L3/L4 water pooling on surface.

Excavator 836 created shallow ditches to allow standing water on the toe of Panel 31 to drain.
