Date:	July 13, 2022	Owner/Client:	New Gold Inc.
Day:	Wednesday	OKC Project #:	1003-19
Prepared by:	Keith Naumann	Project Location:	Rainy River - Ontario

Date:	July 14, 2022	Owner/Client:	New Gold Inc.
Day:	Thursday	OKC Project #:	1003-19
Prepared by:	Keith Naumann	Project Location:	Rainy River - Ontario

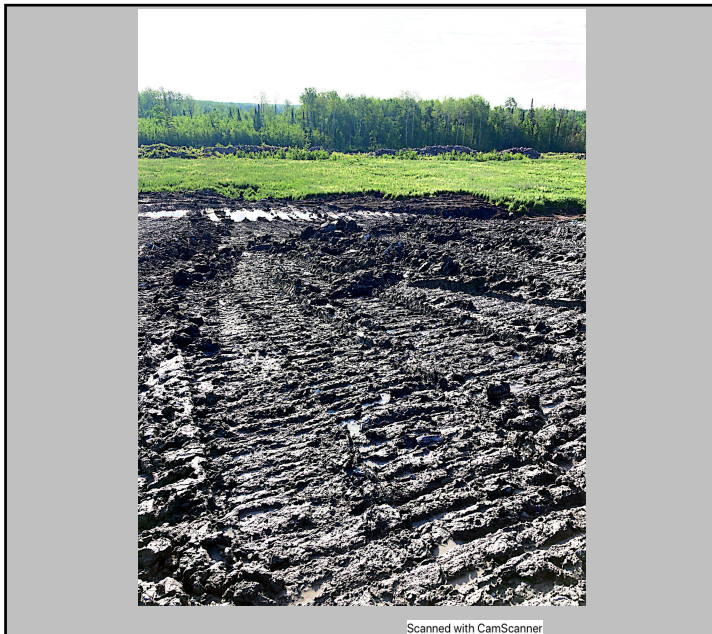
Photo #: 3

Panel 31, Morning. Standing water visible at toe.

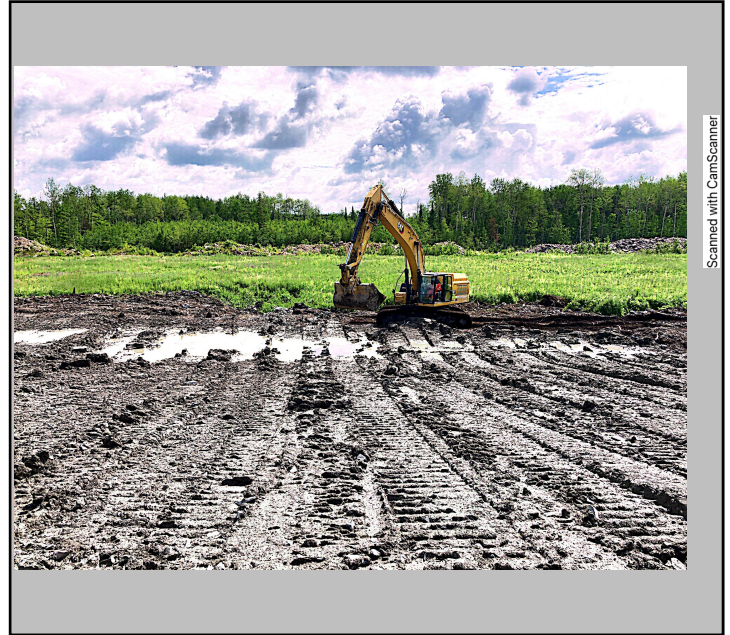
Photo #: 6

Excavator 836 creating drainage paths for standing water on P31.

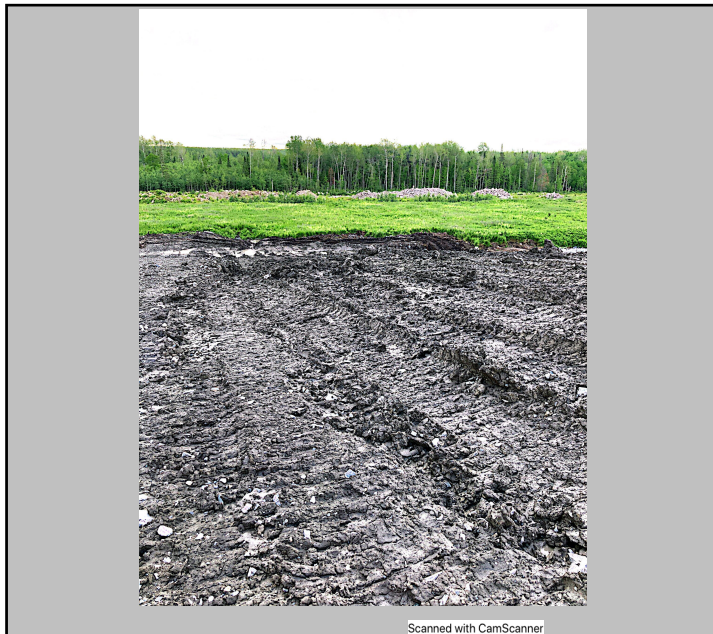
Photo #: 7

P31 L3/L4 some standing water in the morning

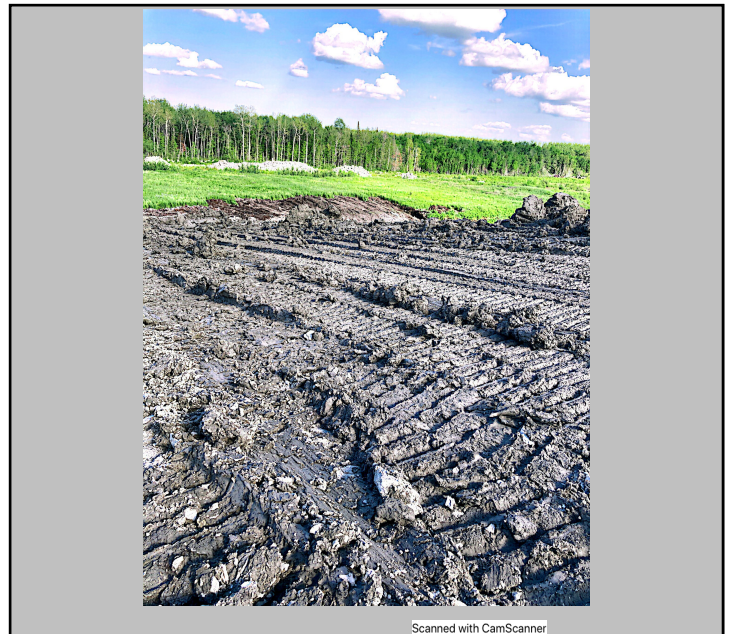
Photo #: 8

P31 mostly dried and workable in the afternoon.

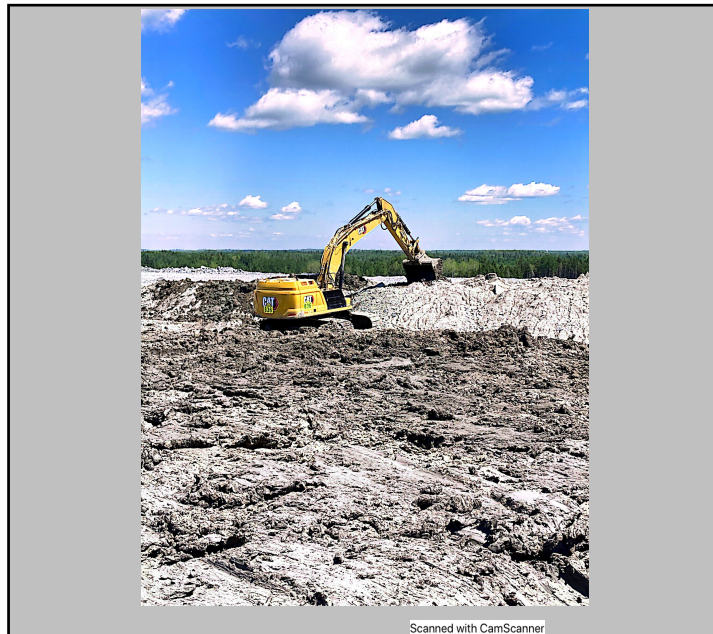
Photo #: 3

Excavator 836 flat topped the stockpile to reduce water pooling.

Excavator 836 reworked North Stockpile to improve drainage.

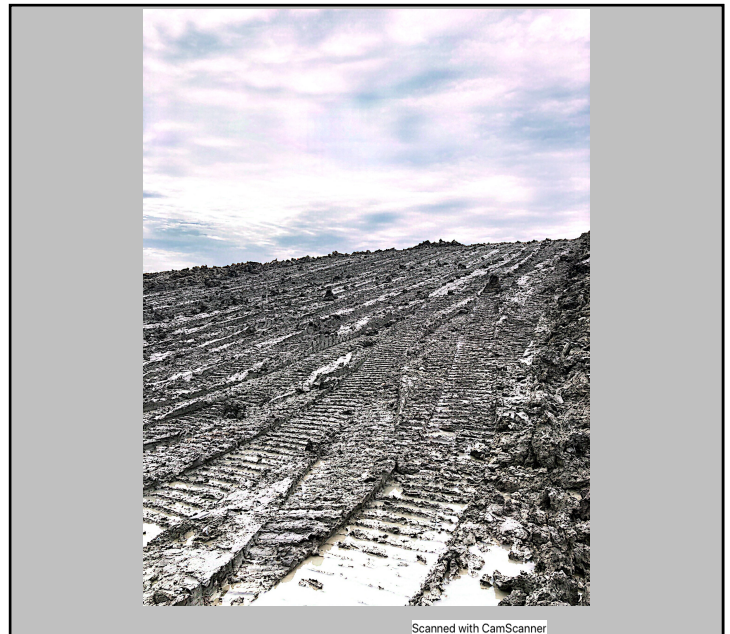
Photo #: 4

NCL L3 P32 full coverage finishing work still required.

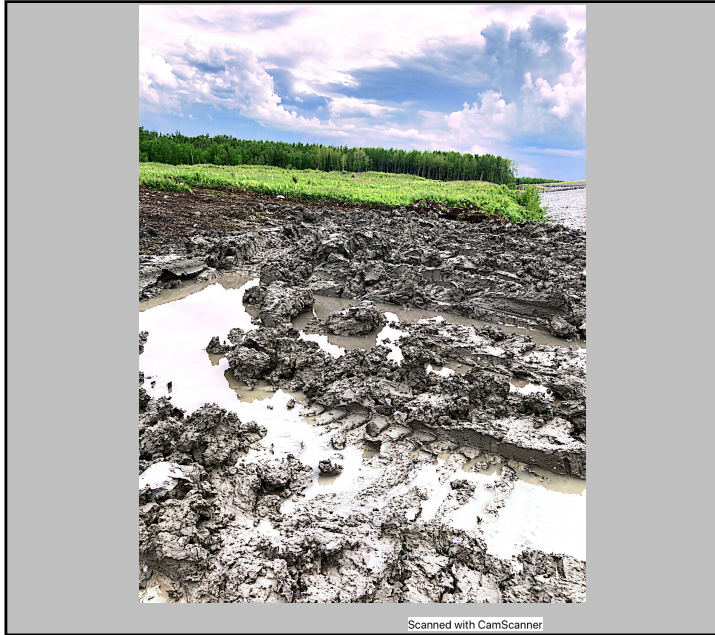
Photo #: 5

Standing water on the toe of NCL L3 P32 after rain.

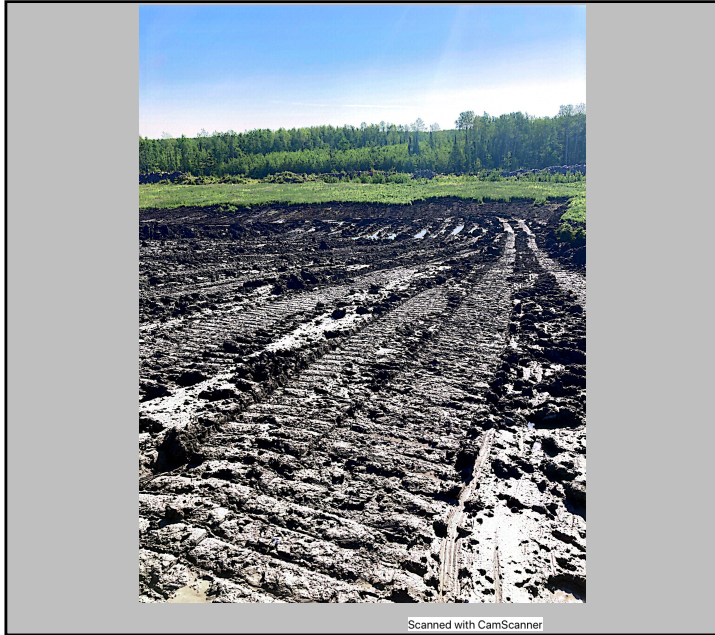
Photo #: 1

Standing water at toe and some throughout panel in the morning. The slope had dried significantly by the afternoon.

P32 NCL L3, Morning.

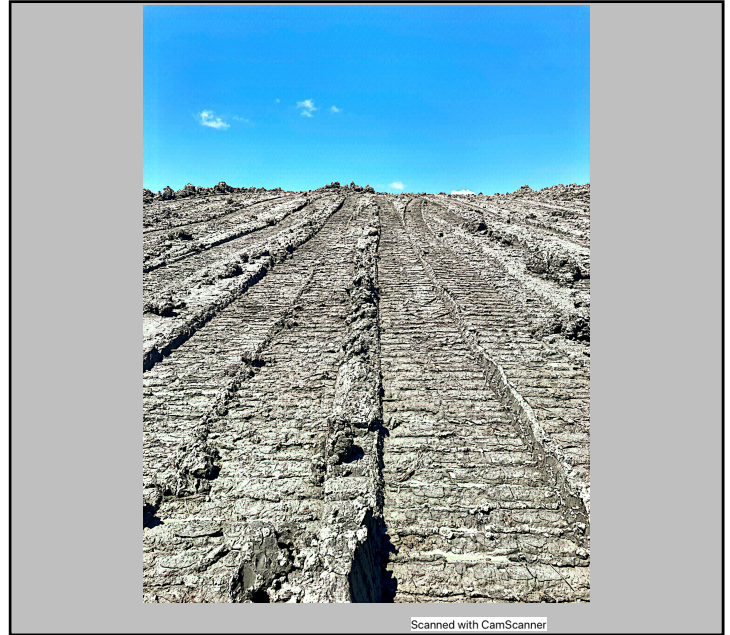
Photo #: 2

P32 NCL L3, Early Afternoon.

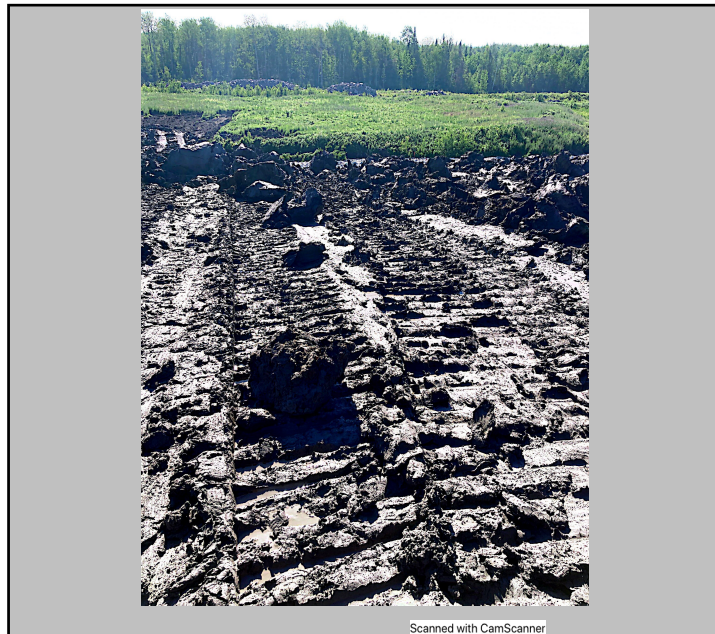
Photo #: 3

Some standing water throughout the panel was present in the morning but dried by the afternoon.

P33 CCL L1, Morning.

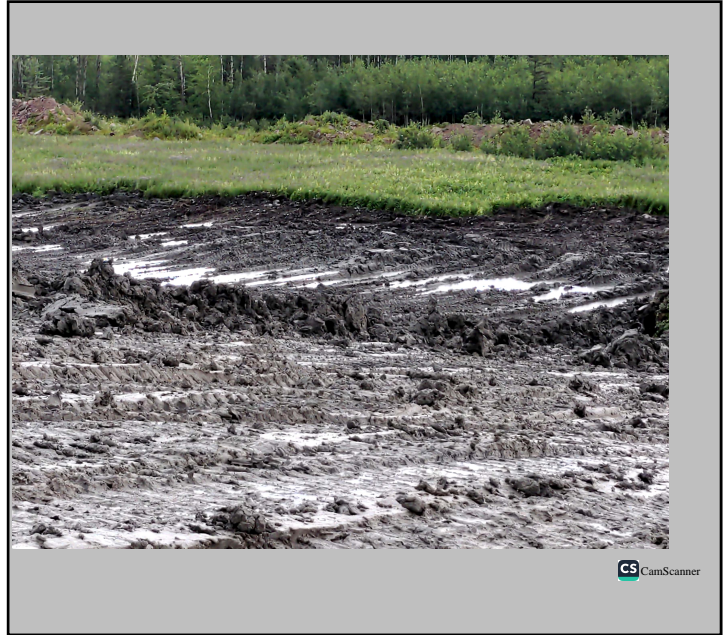
Photo #: 6

Water pooling at the toe of the the panels.

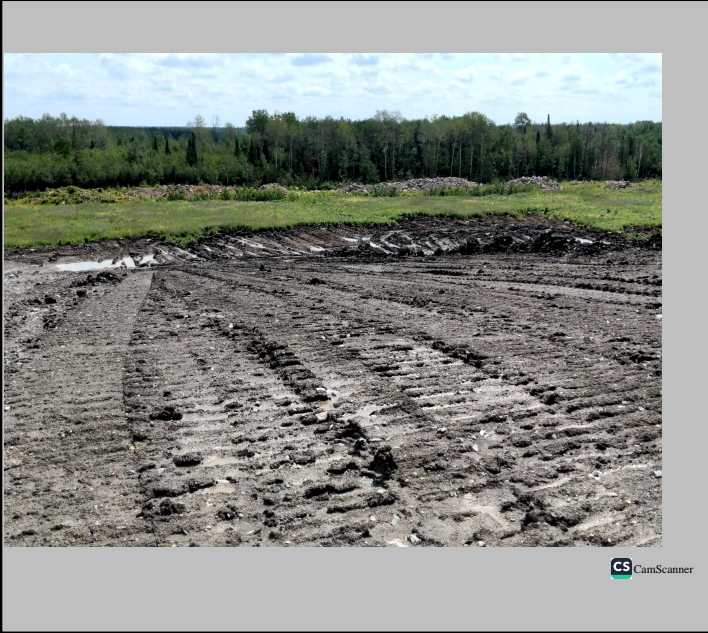
Photo #: 1

Water pooling at the toe of the panels.

Tulloch spoke with NG Coordinator to have an operator use an excavator at the EMRS to create positive drainage at the toe to allow the pooled water flow away from the toe of Panel 31 and 32. This was completed in the afternoon. The panels appear to have dried enough to continue operations tomorrow.
