PHOTOGRAPHS

<b>Date:</b>	May 29, 2022	<b>Owner/Client:</b>	New Gold Inc.
<b>Day:</b>	Sunday	<b>Okane Project #:</b>	1003-027
<b>Prepared by:</b>	Brady Hay	<b>Project Location:</b>	Ontario

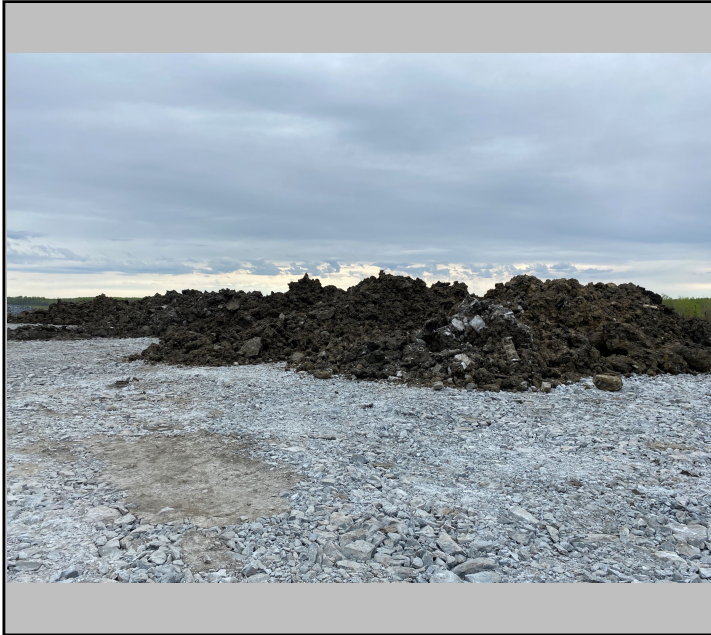
Photo #: 1

NCL material stockpiled overnight

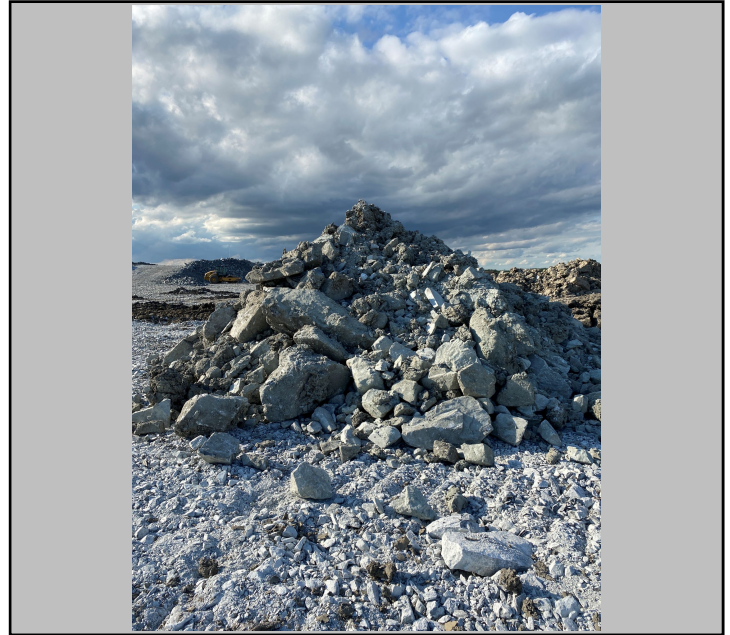
Photo #: 2

Load of stone dumped from active haul

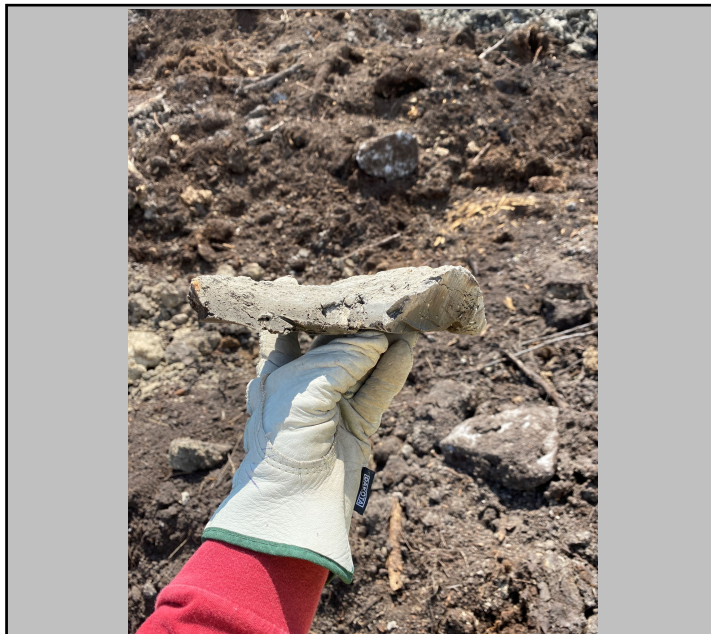
Photo #: 3

Depth of surface desiccation on south side of  
P30, L2 upon inspection

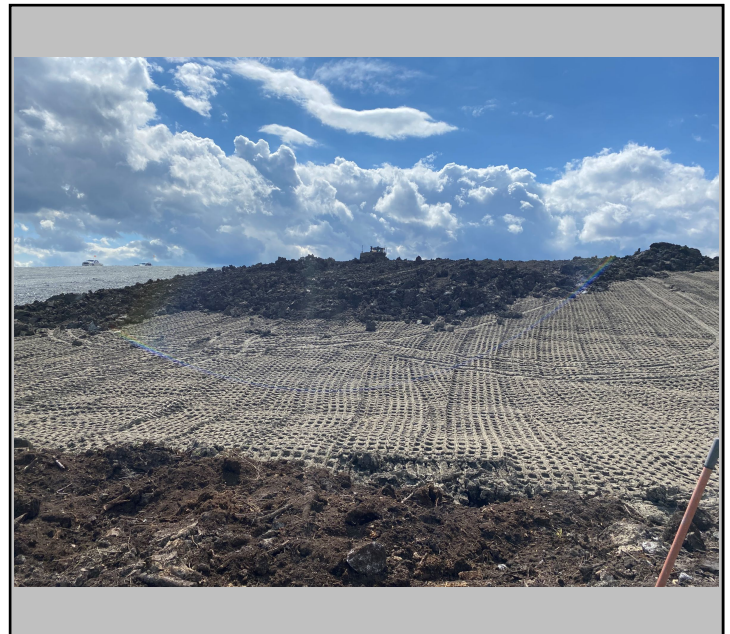
Photo #: 4

P30, L3 placement during desiccation inspection

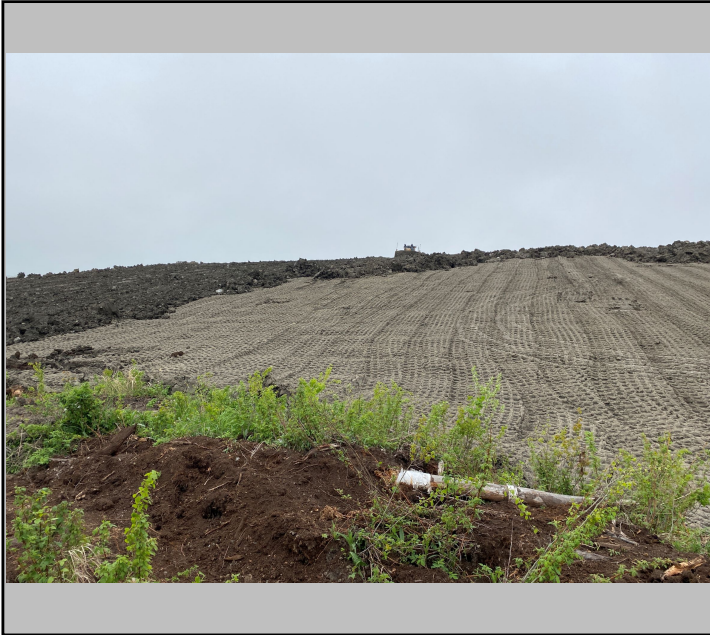
Photo #: 1

P30, L3 placement continued start of day

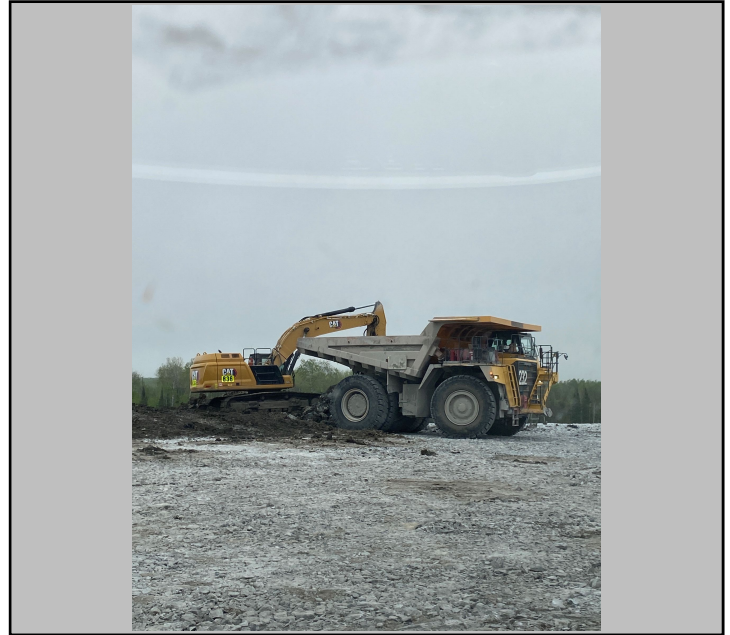
Photo #: 2

General:  
- Comparison sample taken by CQA for 3rd party testing with S534.  
- Previously placed live hauled pile of rock was removed by the excavator and haul trucks.

Previously piled load of stone removed

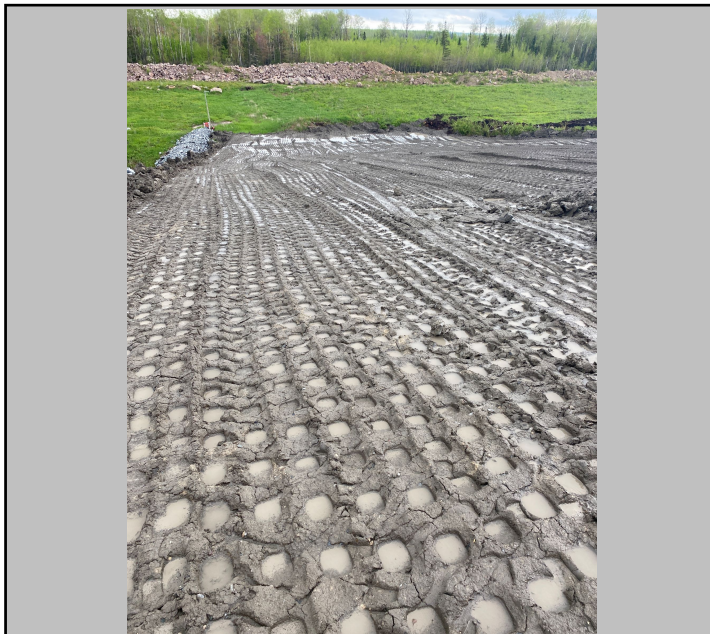
Photo #: 3

P30, L2:  
- Areas still exposed were rehydrated by light showers in the morning until heavy rain caused the material to become too wet with standing water in the sheepsfoot holes and at the toe.

L2 conditions after heavy rainfall

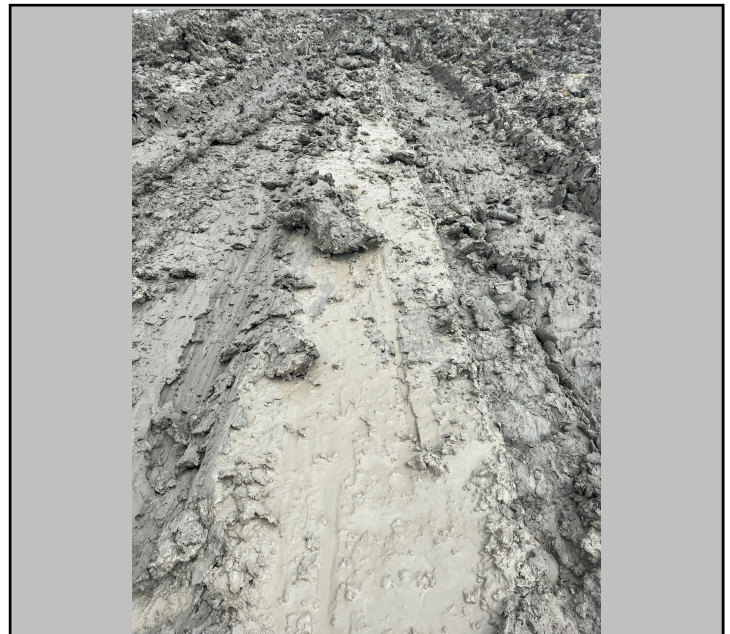
Photo #: 4

P30, L3  
- L3 placement continued in the morning with sporadic light rain helping to rehydrate L2 during the process.  
- at 11:00 construction was halted until 14:00 due to lightning proximity. During this shutdown periods of heavy rain occurred. Once the work stoppage was lifted both L2 and L3 were very wet and standing water was present throughout the panel. CQA contacted CQC to inform them of the conditions and work on the EMRS was stopped for the remainder of the day while the material was left to dry.

L3 conditions after heavy rainfall

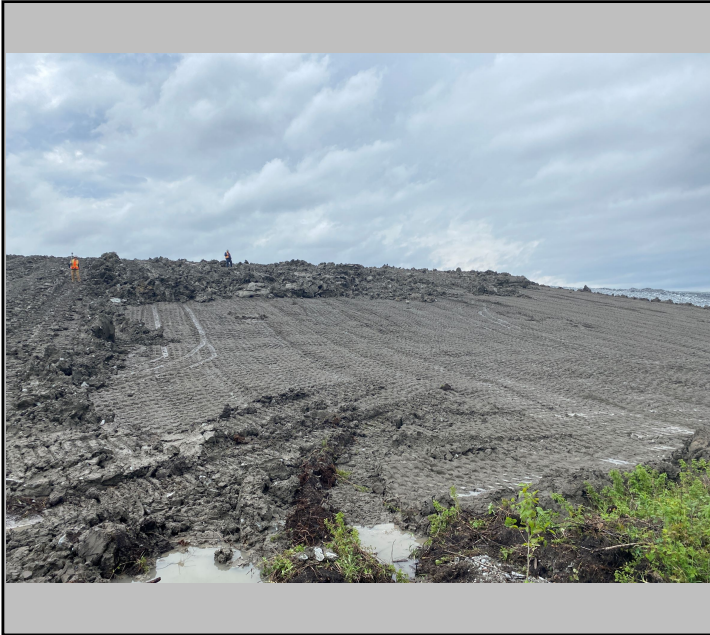
Photo #: 5

P30, L3 progression following work stoppage  
(end of cover construction for the day)

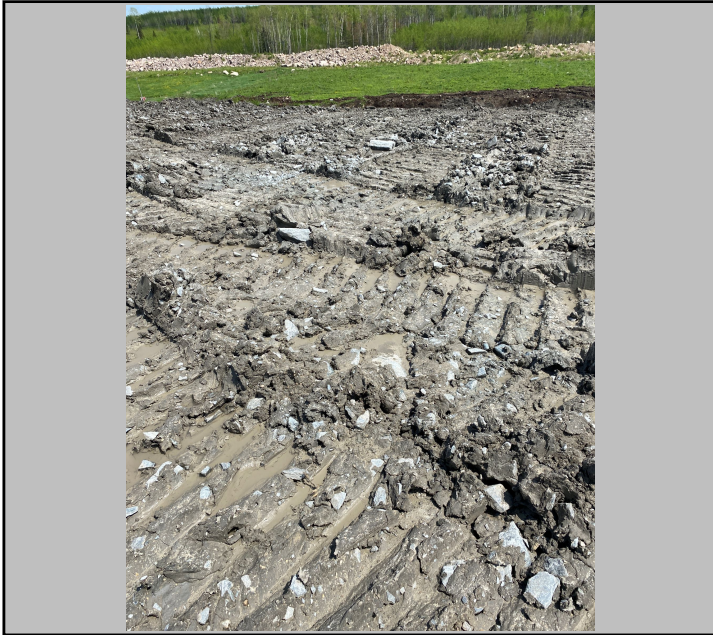
Photo #: 1

- L3 material visually wet following rain with areas of standing water scattered throughout the lift.

P30, L3 material upon afternoon inspection

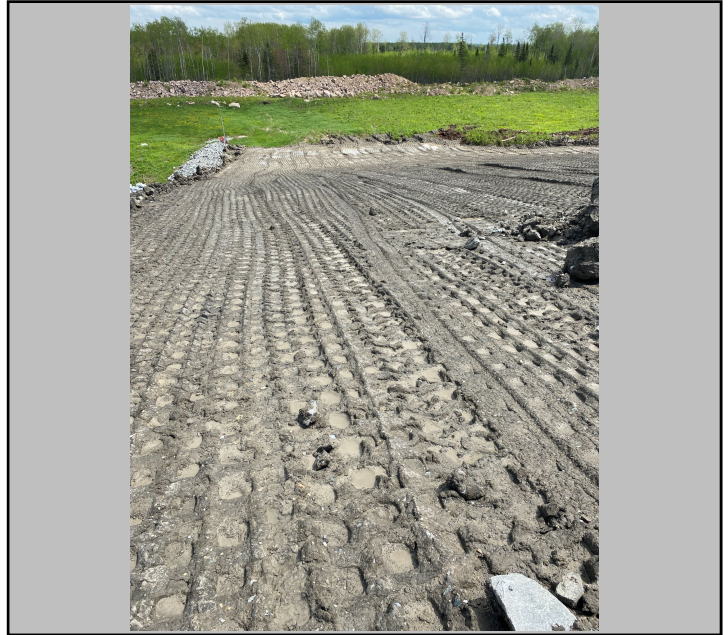
Photo #: 2

- Standing water visible in sheepsfoot marks on the slope with larger areas of standing water at the toe following heavy rain.

P30, L2 material upon afternoon inspection

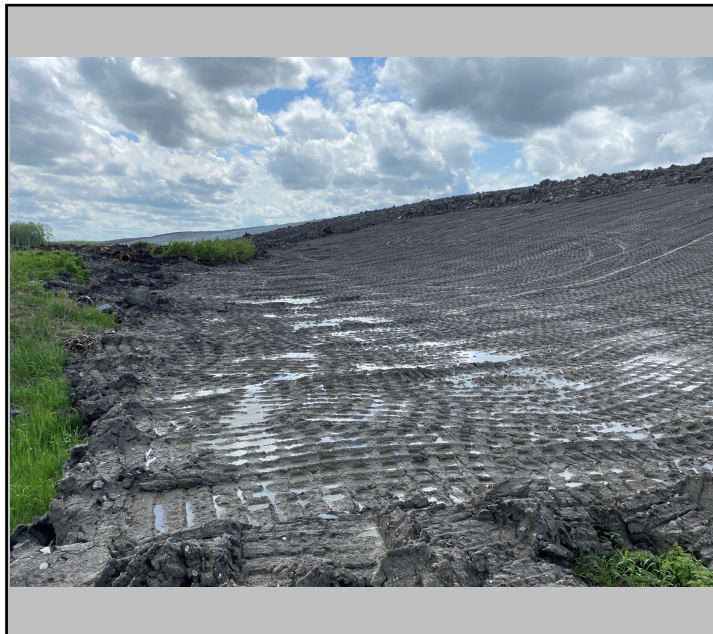
Photo #: 3

P30, L2 toe upon afternoon inspection

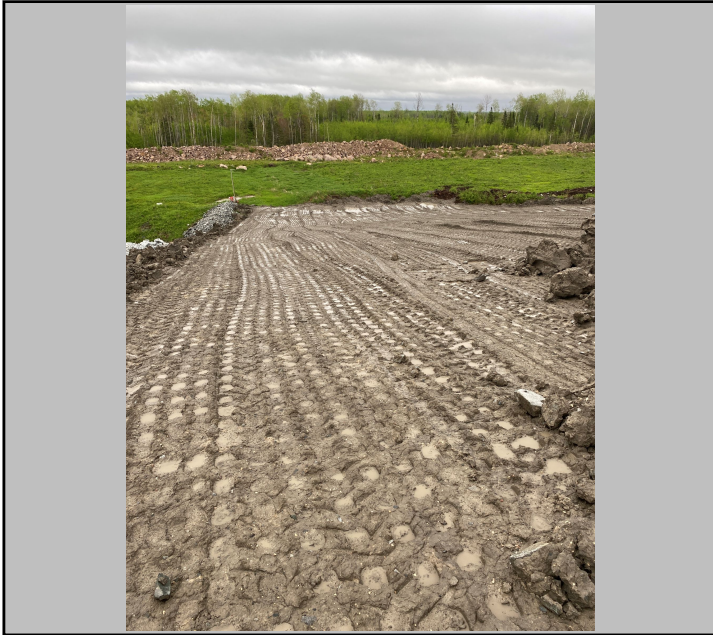
Photo #: 1

P30, L2:  
- Standing water visible in sheepsfoot marks on the slope with larger areas of standing water at the toe following rain.

P30, L2 morning conditions

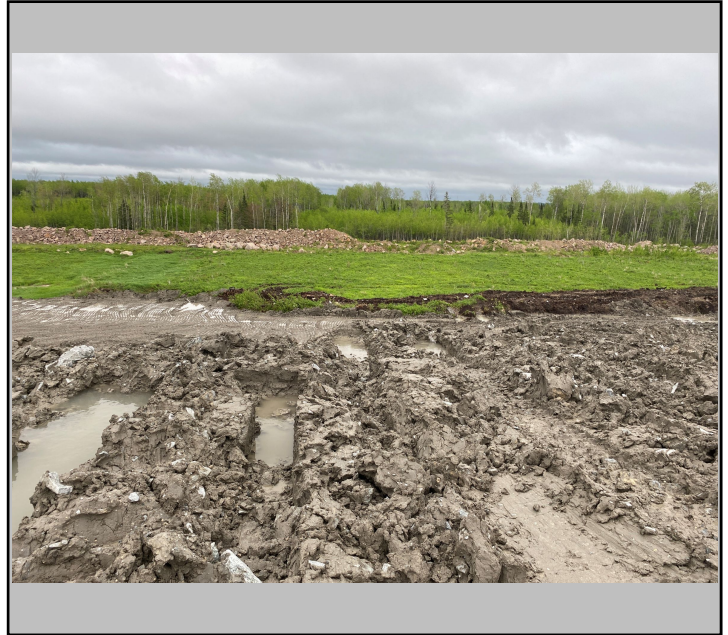
Photo #: 2

P30, L3:  
- L3 material visually wet following rain with areas of standing water scattered throughout the lift.

P30, L3 morning conditions

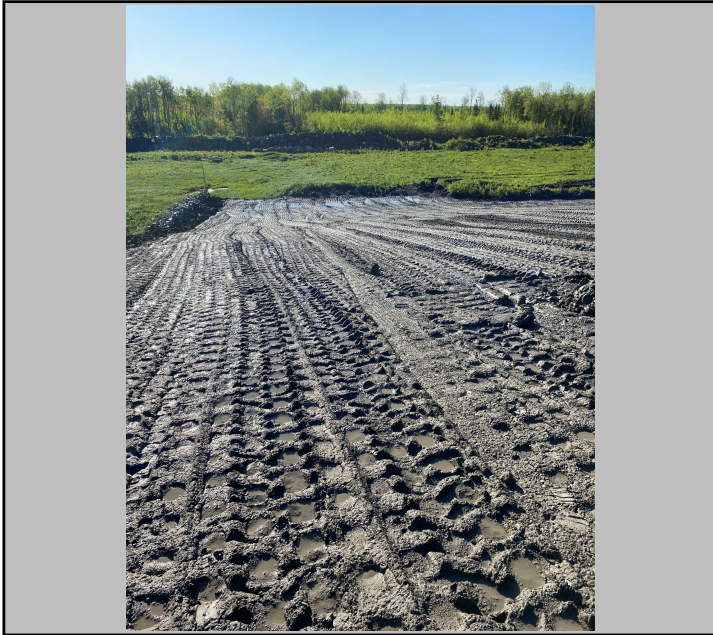
Photo #: 1

- Standing water visible in sheepsfoot marks on the slope with larger areas of standing water at the toe upon morning inspection.
- Warm temperatures and moderate winds throughout the day aided in the drying process of L2. Upon an evening inspection the standing water in the sheepsfoot marks had dried with moist material remaining in the indents. A thin layer of crust had formed on the slope, with areas of standing water still present at the toe.

P30, L2 morning conditions

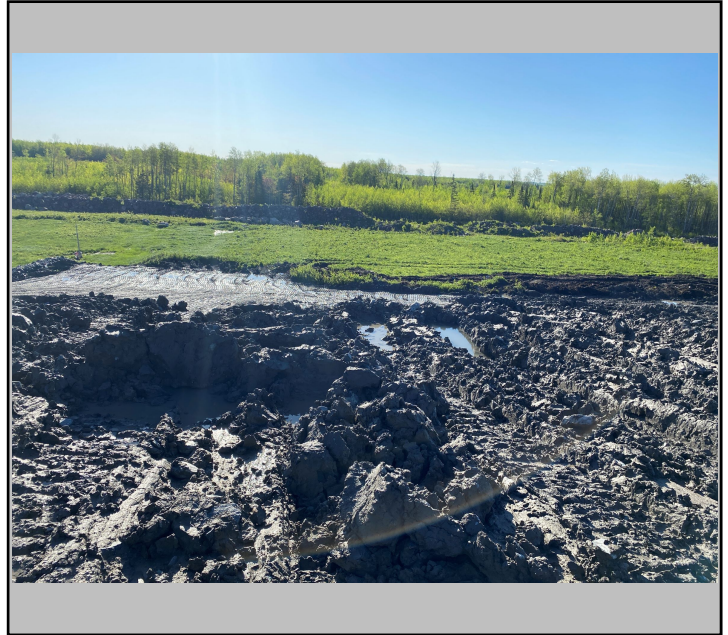
Photo #: 2

- L3 material visually wet following rain with areas of standing water scattered throughout the lift upon morning inspection.
- Improved weather conditions aided the drying of L3. Upon an evening inspection there was a thin layer of crust at the surface of L3 with wet material underneath. Standing water was still present in dozer ruts and at the toe.

P30, L3 morning conditions

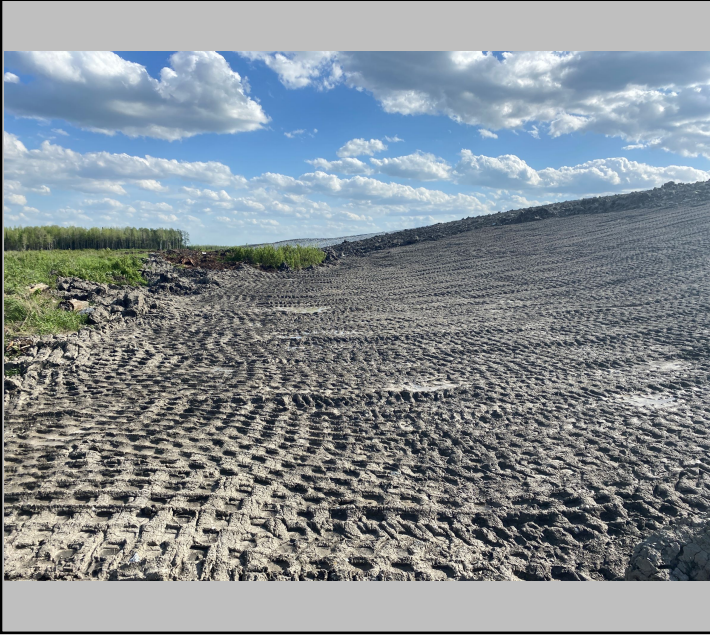
Photo #: 5

P30, L2 toe EOD conditions

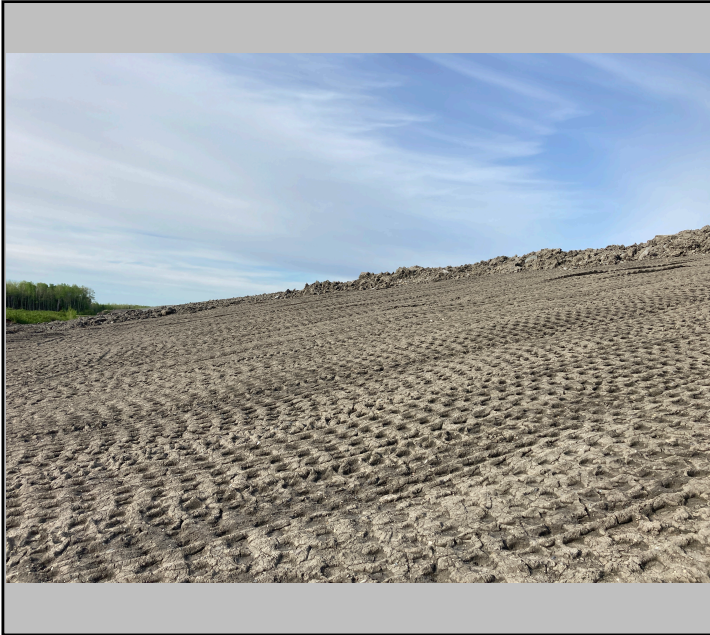
Photo #: 1

- Bottom of sheepsfoot roller divots showing some moisture with the top showing a thin crust.
- Very light afternoon showers keeping L2 slightly moist.
- Standing water at toe of slope minimal.

P30 L2 conditions in the morning

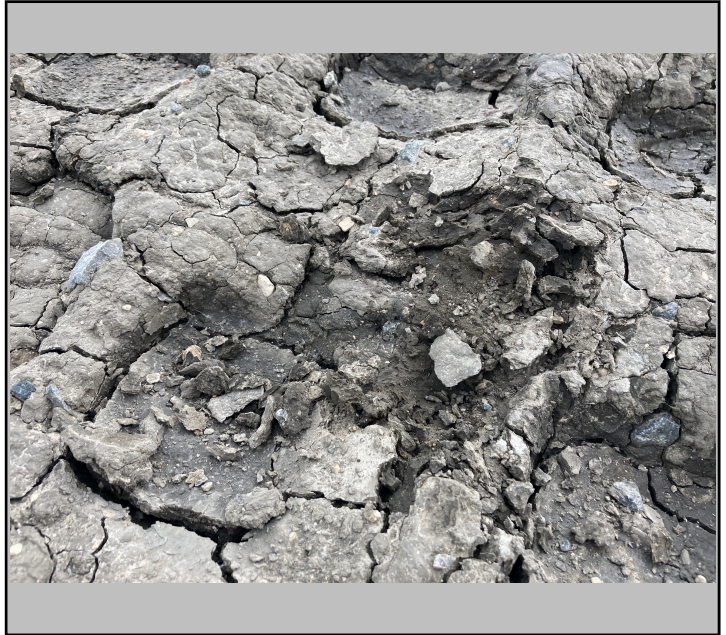
Photo #: 2

P30 L2 showing some surface drying at top of sheepsfoot roller near end of day

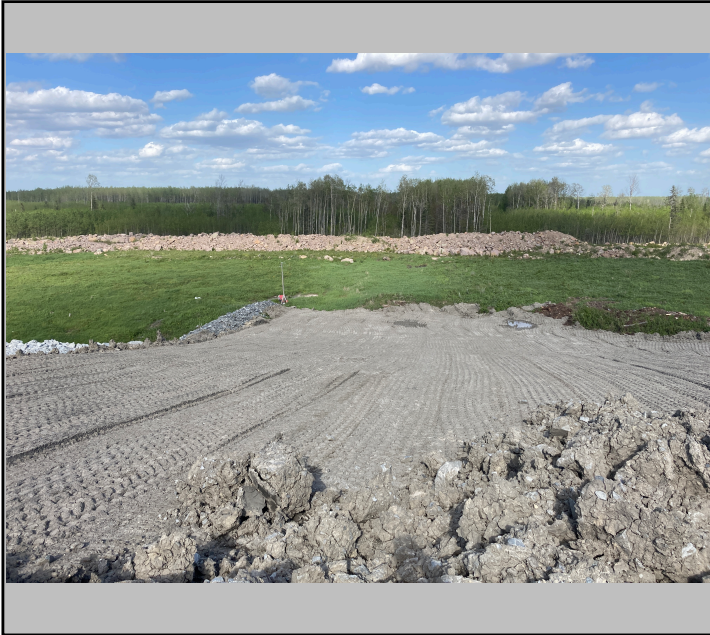
Photo #: 1

- All previous moisture from heavy rainfalls had dried with the exception of two visibly moist areas at the toe.
- Desiccation reaching approximately 2-4cm throughout L2.

P30 L2 dried by end of day

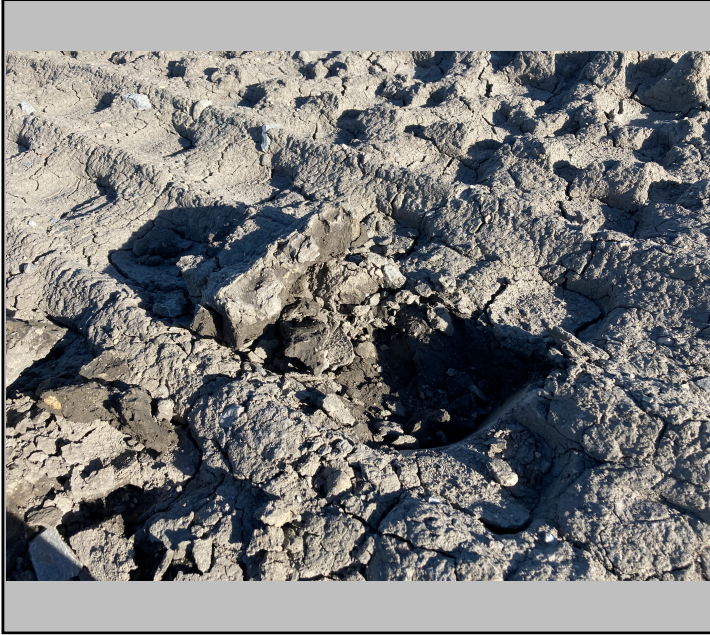
Photo #: 1

P30, L2:  
-Desiccation advancing throughout L2.

P30 L2 desiccation continues

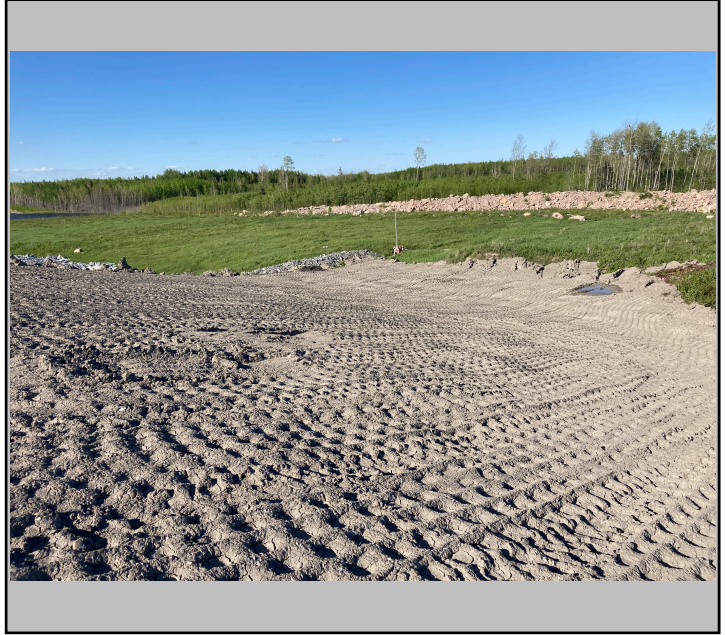
Photo #: 2

P30 L2 at end of day

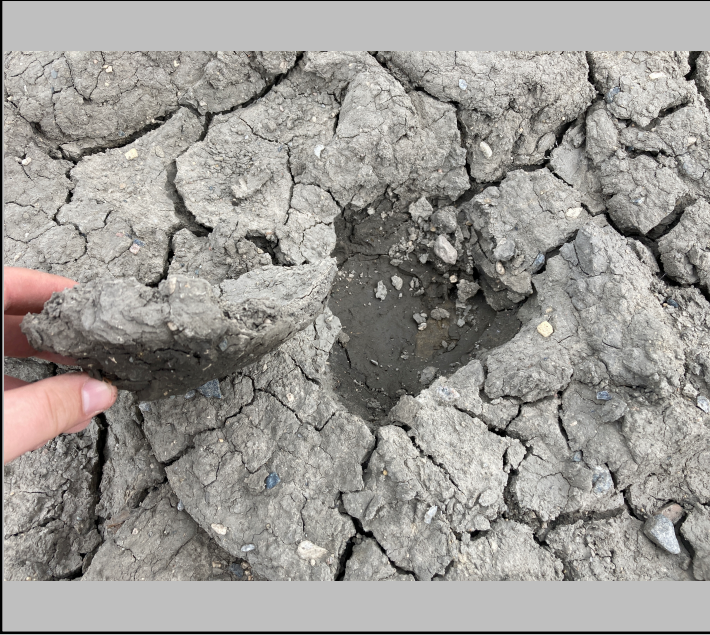
Photo #: 1

P30 L2 desiccation continues

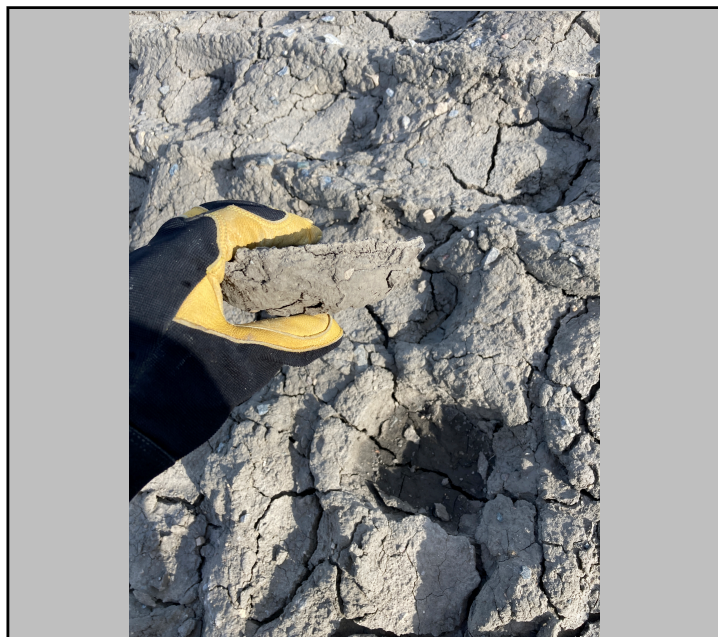
Photo #: 1

P30 L2 desiccation continues

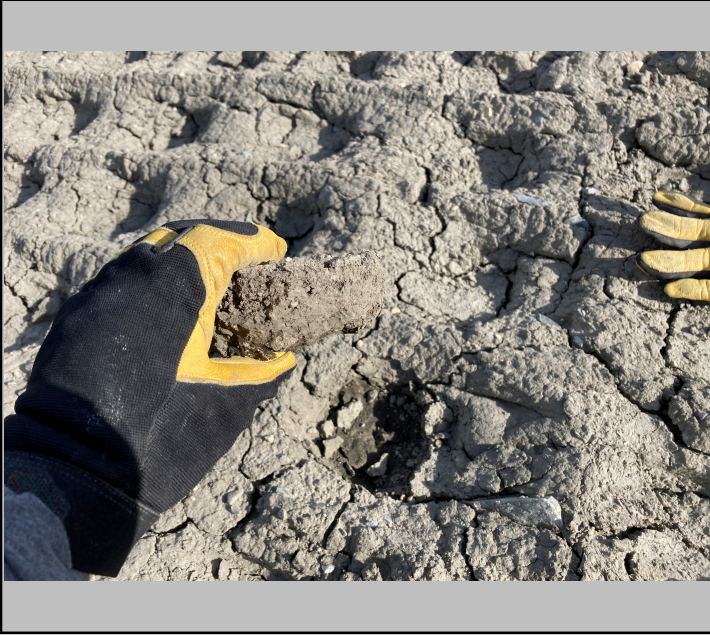
Photo #: 1

P30 L2 desiccation continues

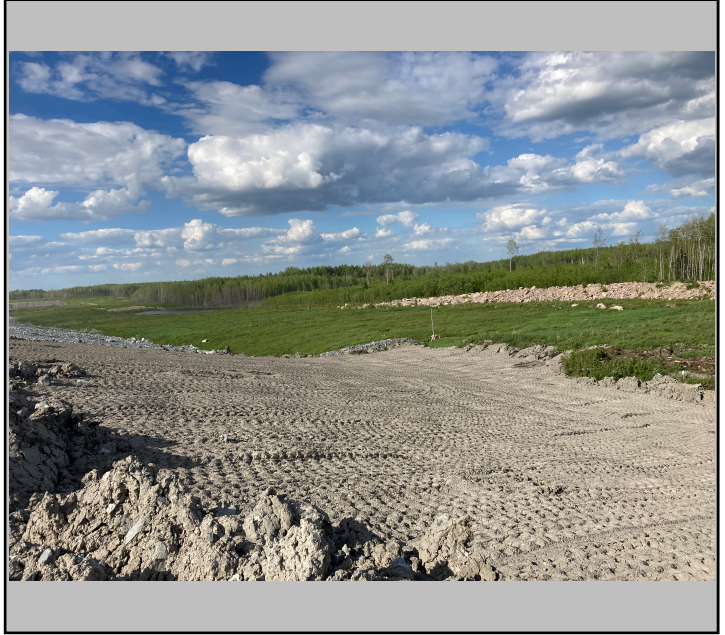
Photo #: 2

Current conditions at P30 L2

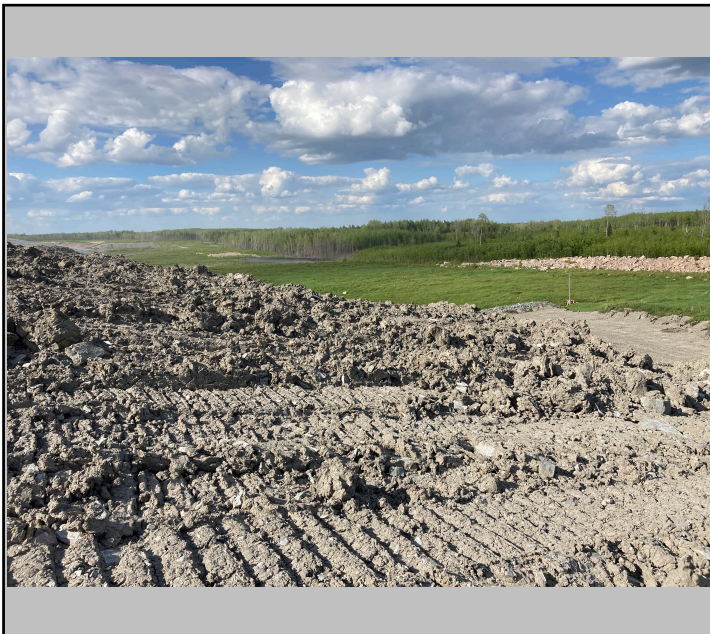
Photo #: 3

Current conditions at P30 L3

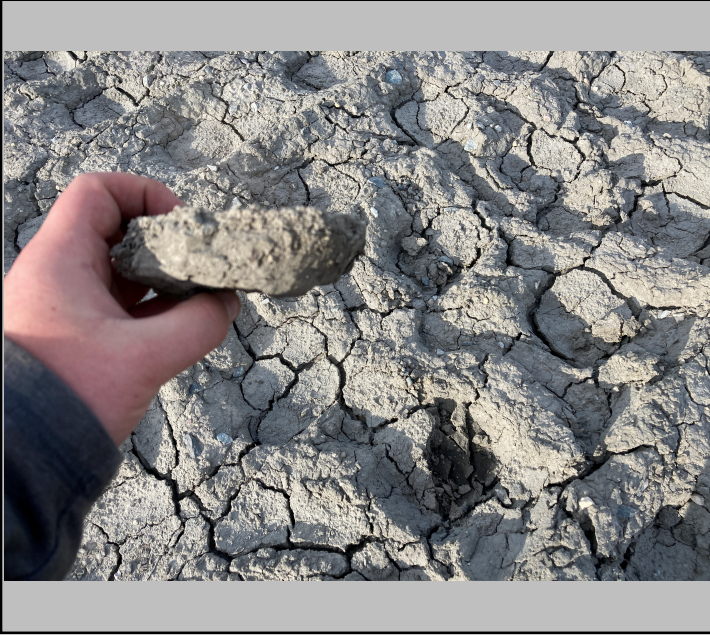
Photo #: 1

P30 L2 desiccation continues

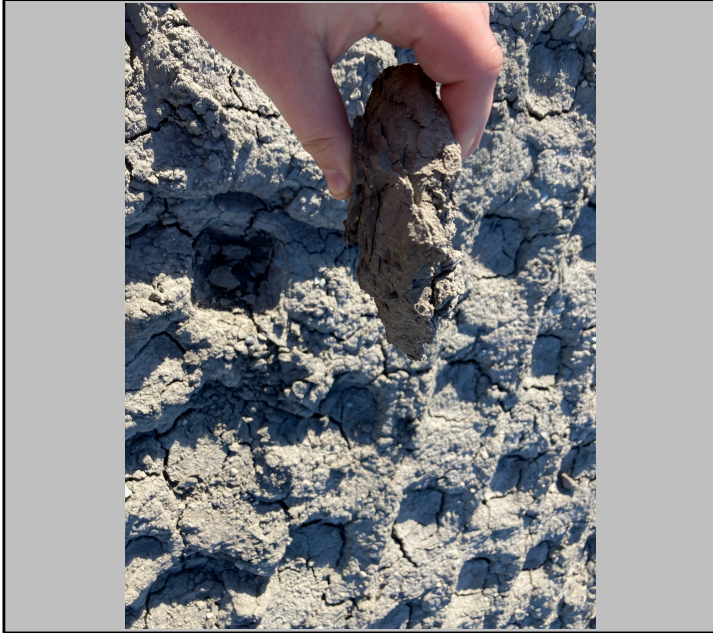
Photo #: 1

P30 L2 desiccation continues

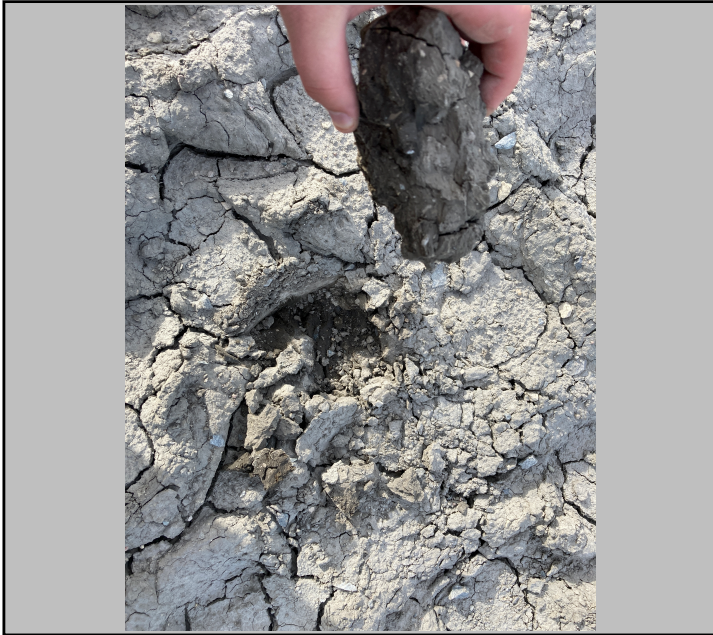
Photo #: 1

P30 L2 desiccation continues

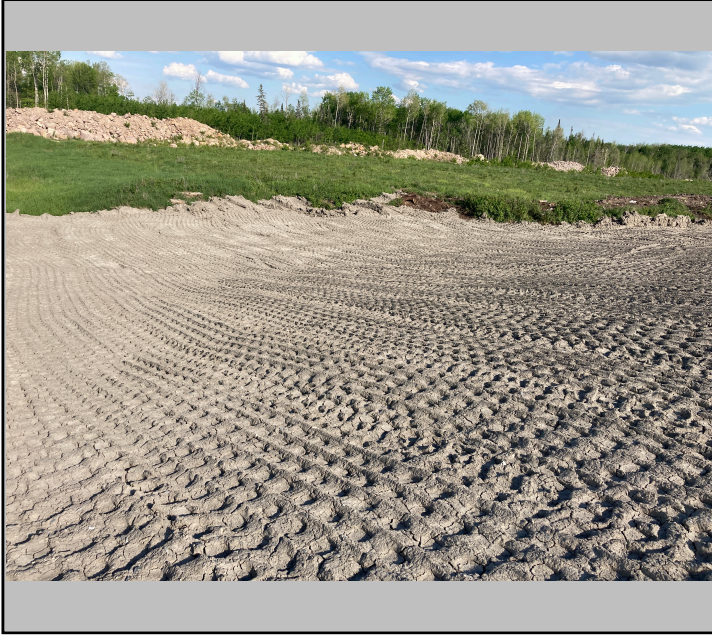
Photo #: 1

P30, L2:  
- Desiccation advancing throughout L2.  
- Morning showers did not affect L2 as material was dried by end of day.  
- Significant cracking throughout L2 due to dryness and time.

P30 L2

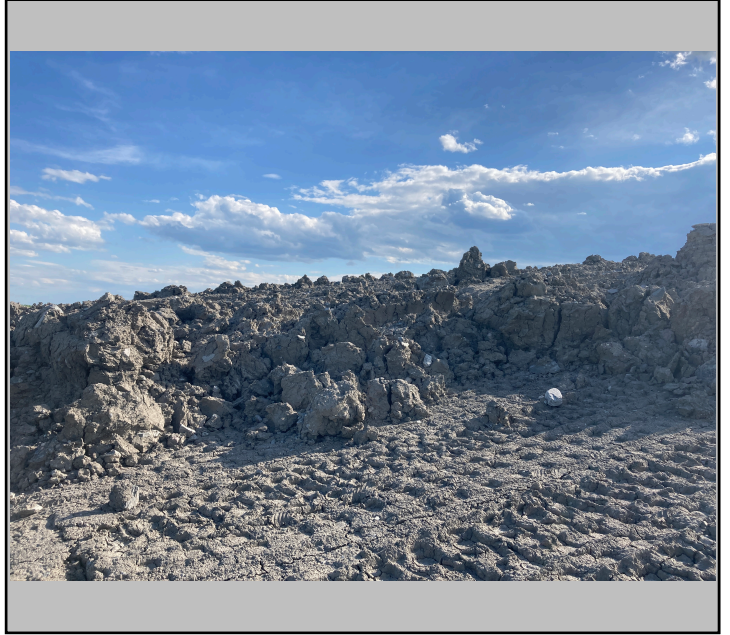
Photo #: 2

P30, L3:  
-Material drying continues. Pockets of standing water still present.

P30 L3

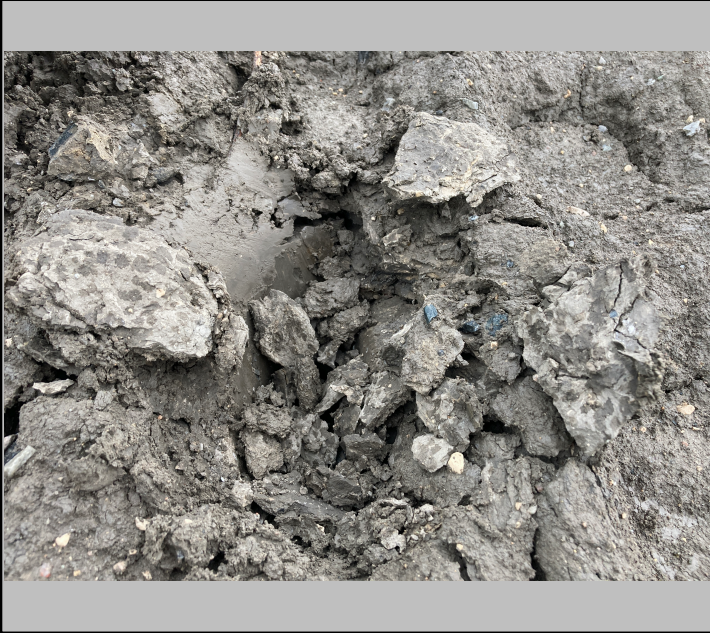
Photo #: 1

P30, L2:  
- Heavy afternoon rainfall moistened top crust of L2.  
- Some dry material still present underneath moist top layer.  
- Cracking of L2 still present after rainfall due to extreme drying.

Dry material still present under rain moistened  
P30 L2 crust

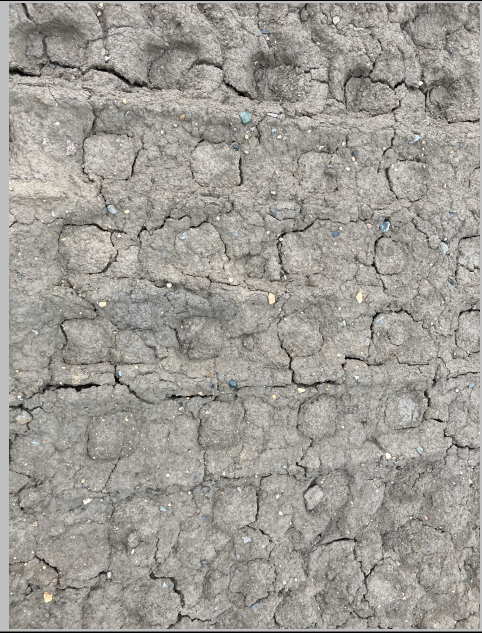
Photo #: 2

P30 L2 cracking still present

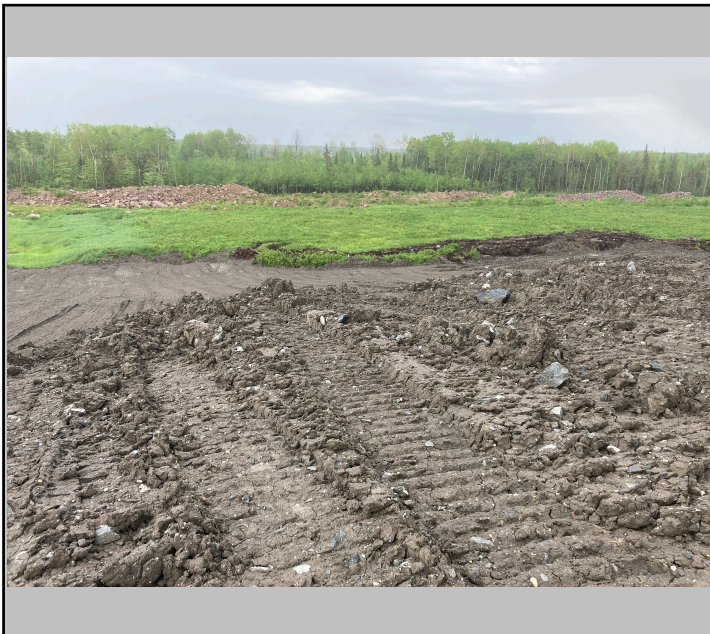
Photo #: 3

P30, L3:  
- Material moistening from rainfall.  
- Pockets of standing water present

P30 L3 material moistening
