PHOTOGRAPHS

<b>Date:</b>	May 29, 2022	<b>Owner/Client:</b>	New Gold Inc.
<b>Day:</b>	Sunday	<b>Okane Project #:</b>	1003-027
<b>Prepared by:</b>	Brady Hay	<b>Project Location:</b>	Ontario

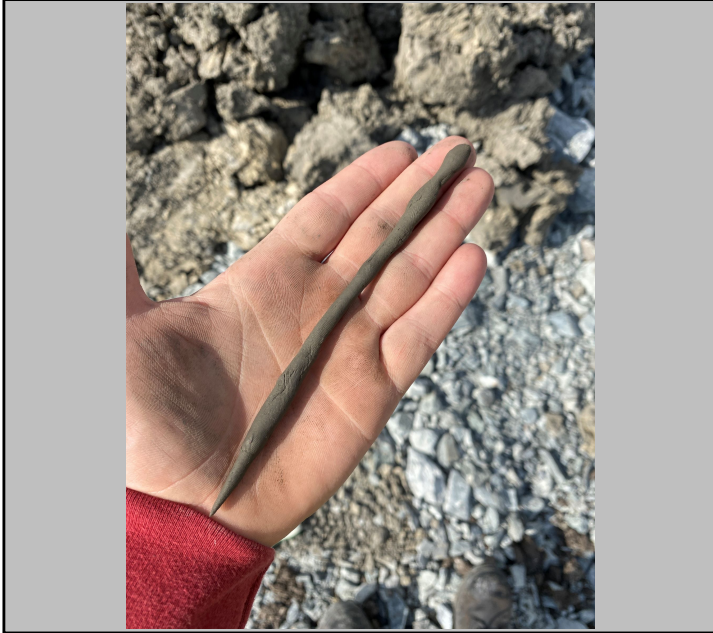
Photo #: 5

P30, L3 material

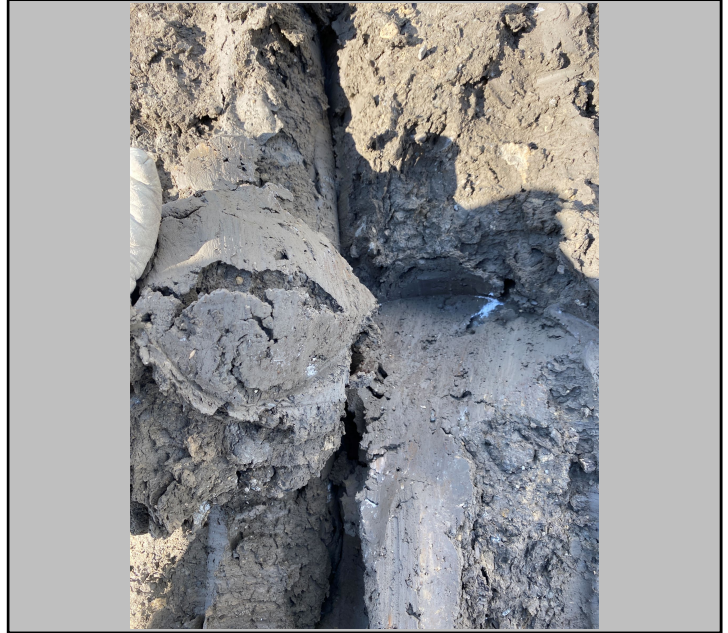
Photo #: 6

P30, L3 material

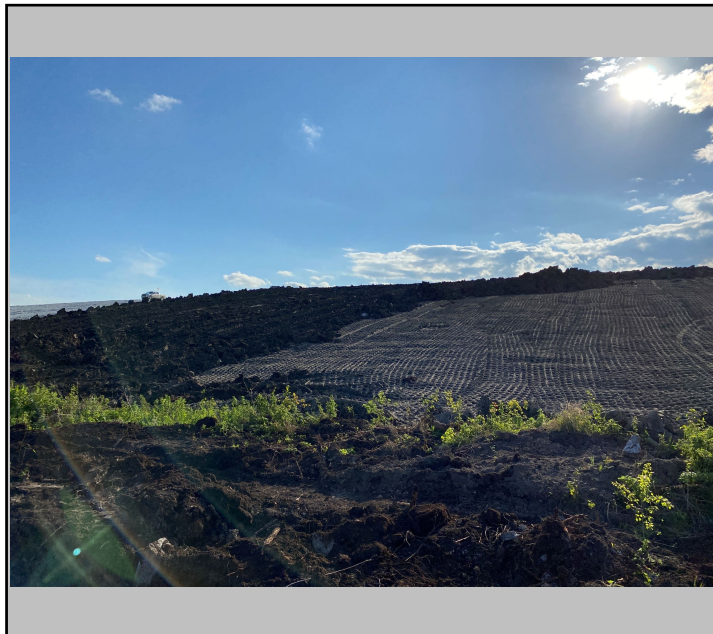
Photo #: 7

P30, L3 placement at end of day

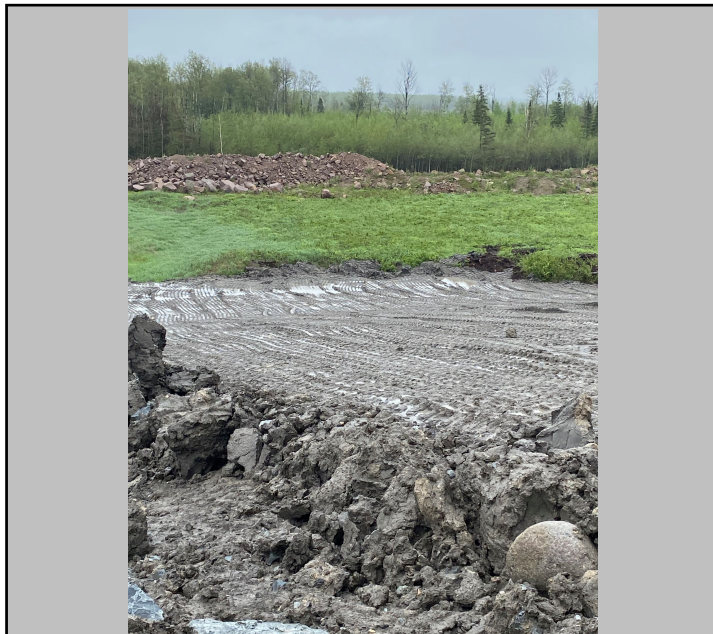
Photo #: 3

P30, L2 EOD conditions

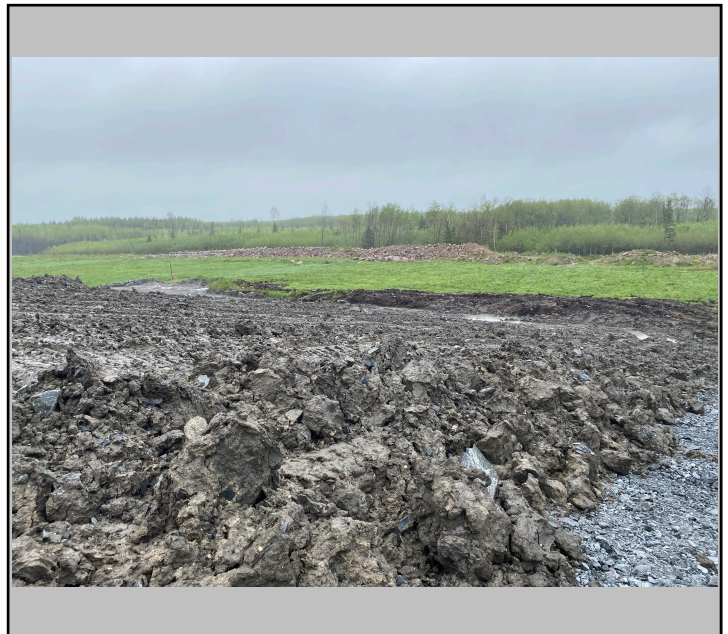
Photo #: 4

P30, L3 EOD conditions

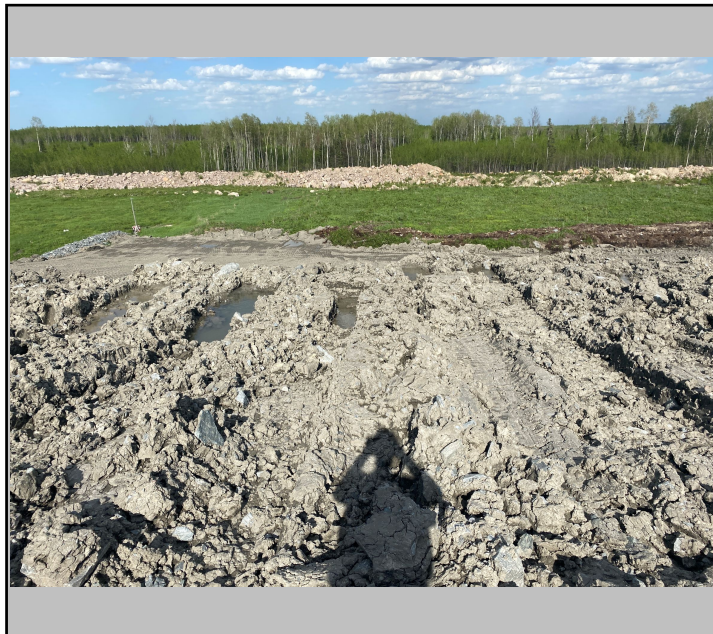
Photo #: 3

P30, L3 EOD conditions

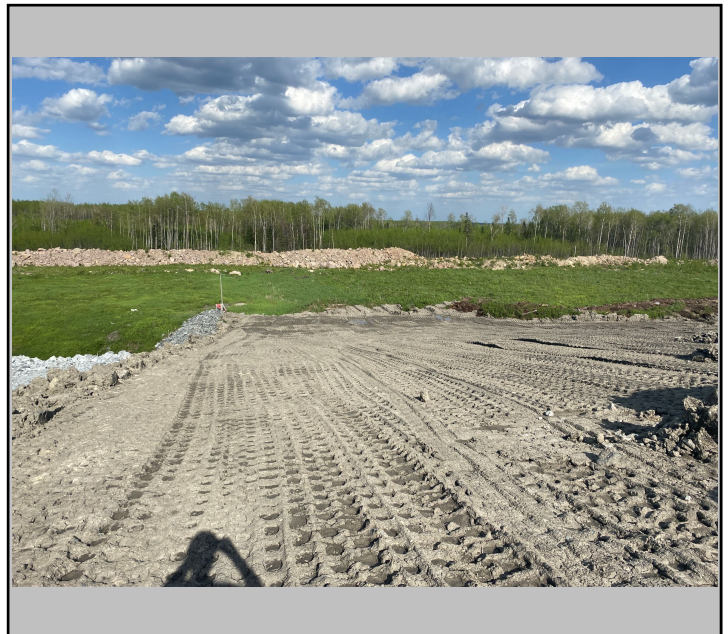
Photo #: 4

P30, L2 EOD conditions

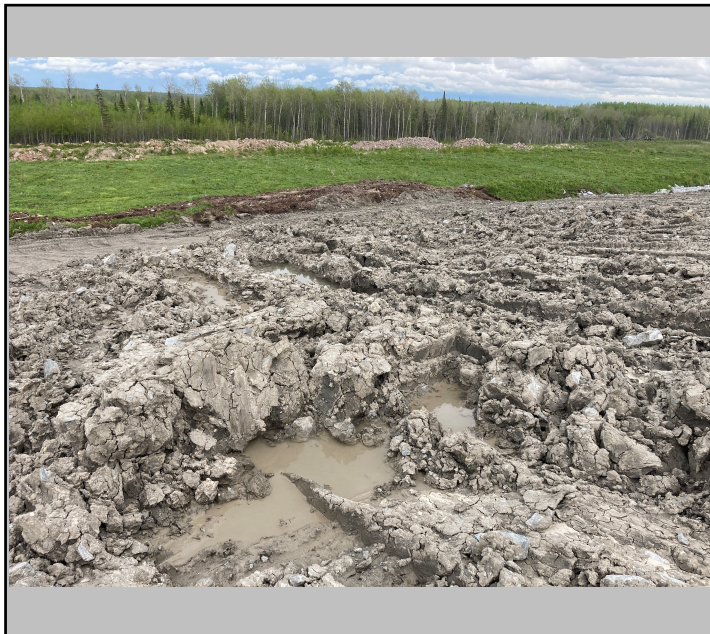
Photo #: 3

P30 L3 material drying at end of day, some pockets of water still present

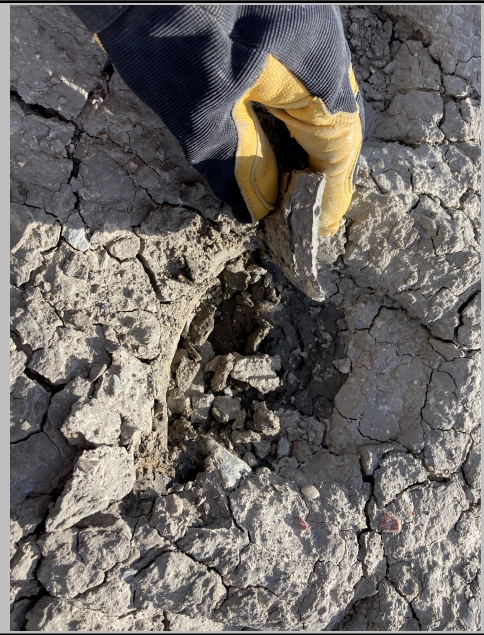
Photo #: 2

P30 L2 desiccation reaching approximately 2-4 cm throughout

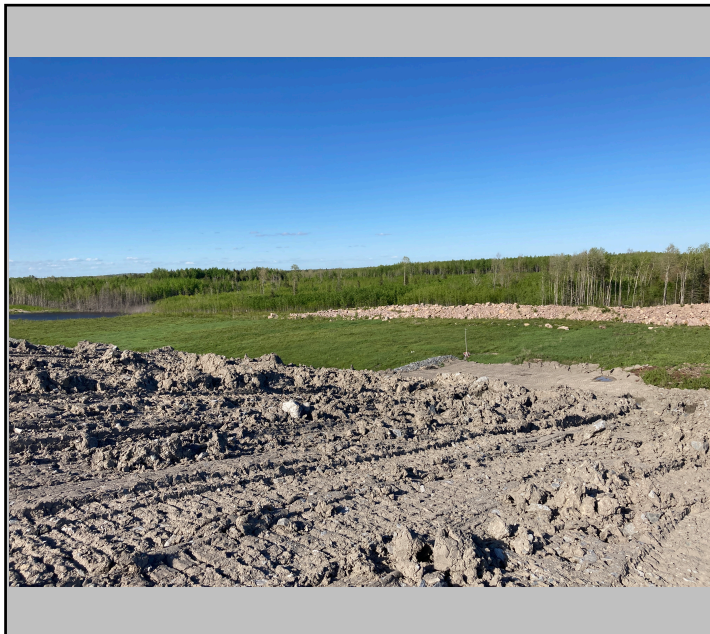
Photo #: 3

P30 L3 at end of day
